Ice Jam Flood Assessment for the St. John River Basin, Aroostook County, Maine

Special Report 95-15

Prepared for
U.S. ARMY ENGINEER DIVISION, NEW ENGLAND

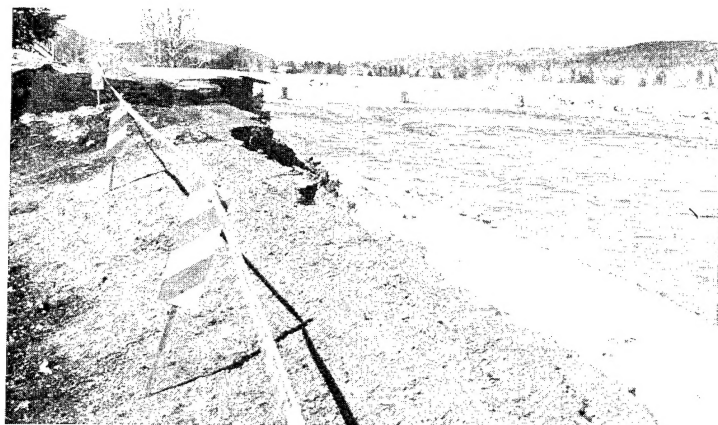
a. Bridge and road section destroyed.

Figure 1. Ice jam damage in the town of Allagash, Maine, April 1991.

(1973–1992) (Table 1). Most recently, in the spring of 1991, devastating ice jam floods on the St. John River caused damage estimated at \$14,000,000. On 9 and 10 April 1991, the two bridges in the village of Dickey, located in the town of Allagash, 1000 ft of state highway and 11 houses were destroyed (Fig. 1) and an additional 22 houses were damaged. On 13–14 April, ice jam floods on the Aroostook River caused damage to shoreline, roads, 16 houses in the town of Fort Fairfield and properties in the village of Crouseville located in the town of Washburn.

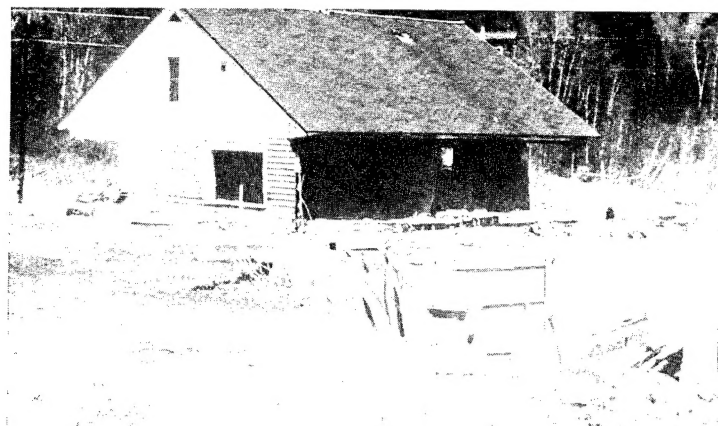
b. Private home moved from foundation.

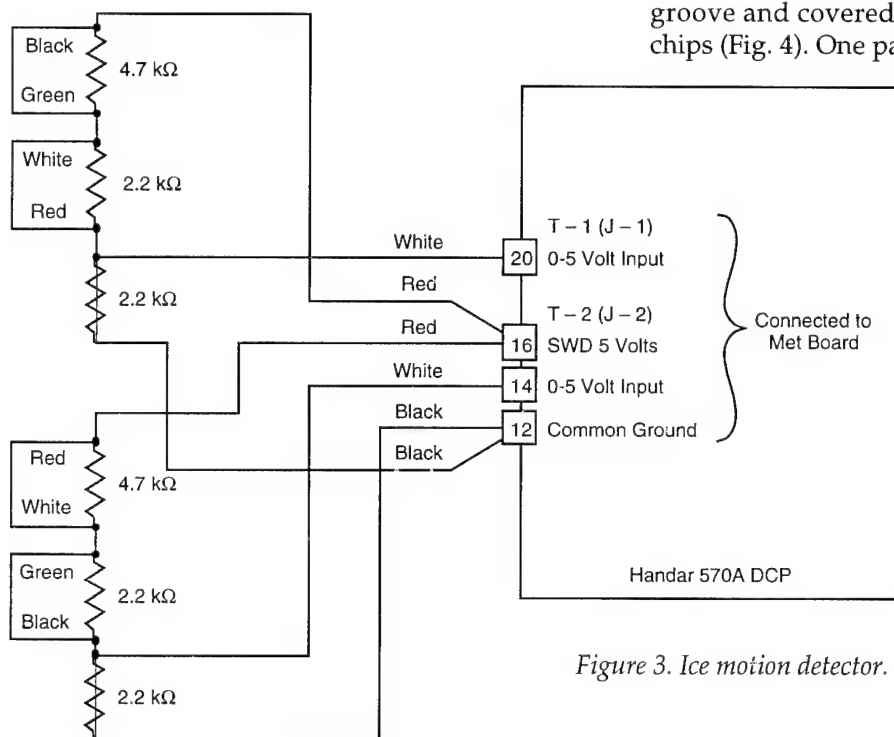
Figure 3. Ice motion detector.

bridge on the upper St. John River. Each sensor consisted of two pairs of electrical wires. Each pair, of different length, is joined at one end by a waterproof connection and at the other end is connected to a series of resistors, which in turn are connected to the USGS Nine Mile stream gaging station's Data Collection Platform (DCP). An electrical diagram for the system is shown in Figure 3. The voltage measured by the DCP determines if both pairs of wires are intact, if one or the other pair has broken, or if both pairs have broken.

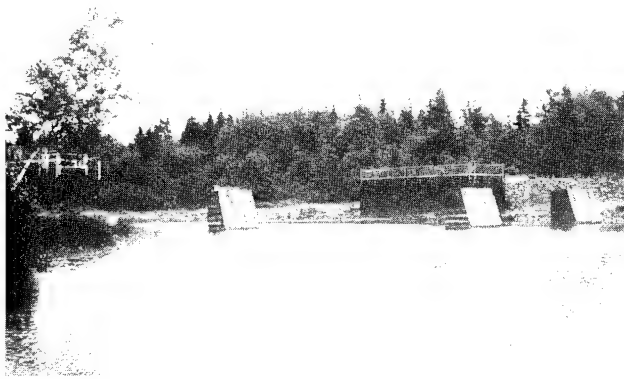
Figure 7. Example of rock-filled crib, Cherryfield, Maine.

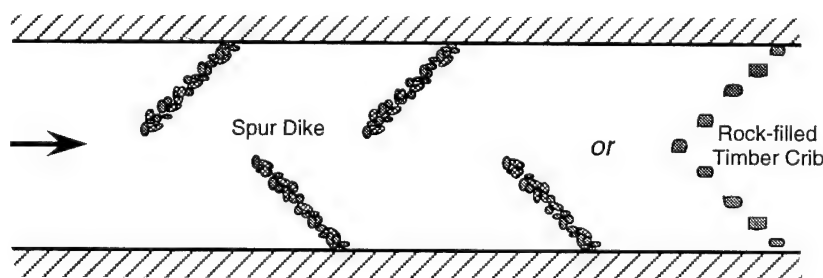
Figure 8. Spur dikes and rock-filled timber cribs for ice control.

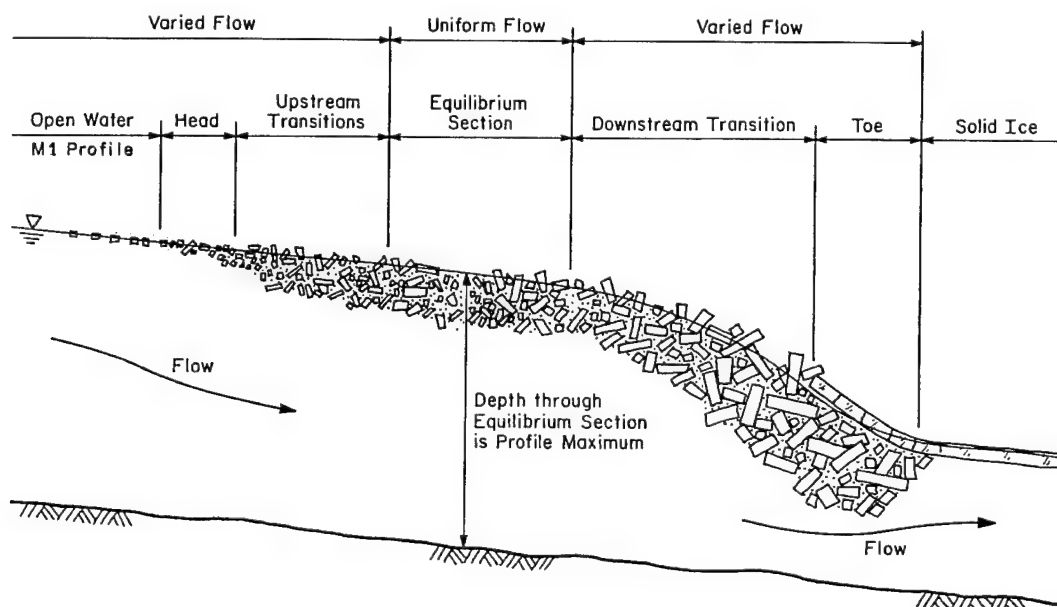
the upstream end, or head, of the jam, flow depth again makes a transition towards the lower flow depths associated with the open water conditions upstream. The longitudinal profile of a typical fully developed breakup ice jam is shown in Figure 10.

Figure 10. Longitudinal profile of a typical breakup ice jam.

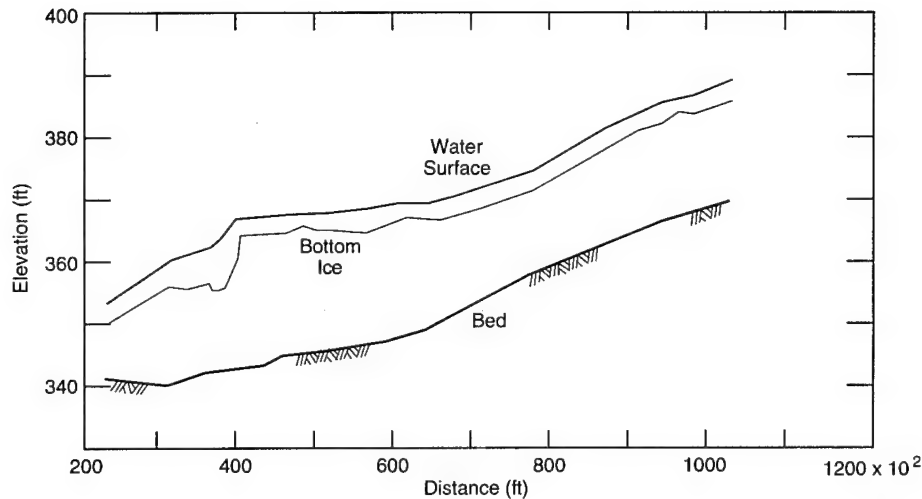
Water surface profiles for the Aroostook River were calculated using the HEC-2 computer program (USACE 1990). This analysis was based on a verified open water HEC-2 data deck and downstream rating curve prepared by NED personnel. The original deck provided to CRREL

Figure 11. Water surface profile for an equilibrium ice jam on the Aroostook River between Fort Fairfield and Caribou dam.

covered approximately 5 miles of the river, extending from river station 236+54 at the U.S.-Canadian border to river station 490+70. This original data deck was extended by CRREL to river station 1034+00, which is just below the dam in the town of Caribou, so that the relative effectiveness of alternative ice control options could be compared as described later. Cross-section data for the extended deck were derived from USGS 7.5-minute topographic maps. Manning's n values were retained from the original data deck. The extended portion of the data deck has not been verified against field data and should be considered only approximate.

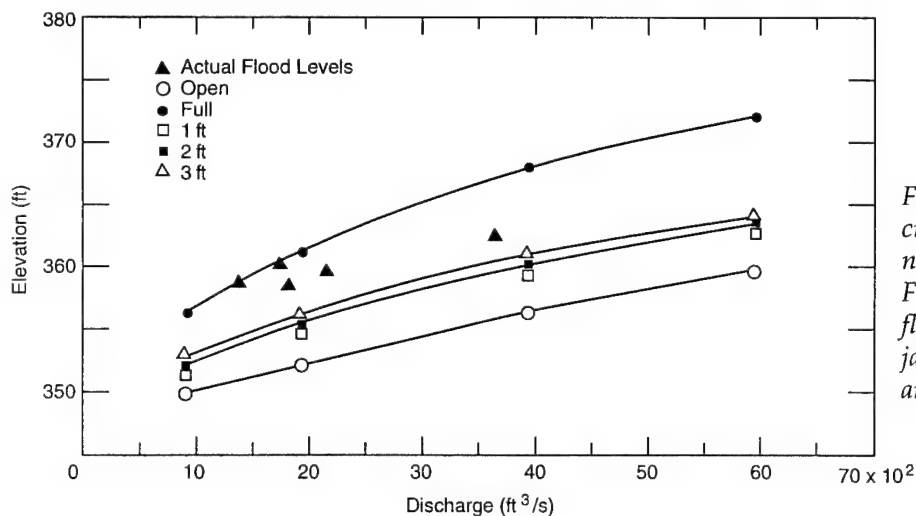
Figure 12 shows an ice-affected rating curve

Figure 12. Ice-affected rating curves of the Aroostook River, near Limestone Road bridge, Fort Fairfield. Shown are the flood levels reached during ice jams in 1932, 1936, 1940, 1973 and 1976.

developed for river station 402+84, which corresponds to the Limestone Road bridge. The curves represent open water, ice-covered and ice-jammed conditions in order of increasing stage. The figure shows the calculated ice-affected water levels for discharges up to a 25-year open water flood (60,000 ft³/s). It is unlikely, however, that an ice cover would remain intact for discharges much greater than 10,000 ft³/s or that a jam would remain stable for discharges as large as a 5-year open water flood (43,000 ft³/s). For the major ice-related floods reviewed in Table 3, peak stages for all but one were reached at discharges of no more than 23,000 ft³/s. The remaining flood, in 1976, had a discharge on the order of 37,000 ft³/s. A 2-year flood is on the order of 31,000 ft³/s. Prior to reaching a 5-year recurrence interval discharge, it is likely that any ice jam would release, and water levels would return to open water levels. Thus, the true rating curve would likely follow the curve for an ice cover of appropriate thickness up to a discharge

of 10,000 to 15,000 ft³/s, and would then increase to levels no greater than the equilibrium jam curve (depending on ice conditions and supply).

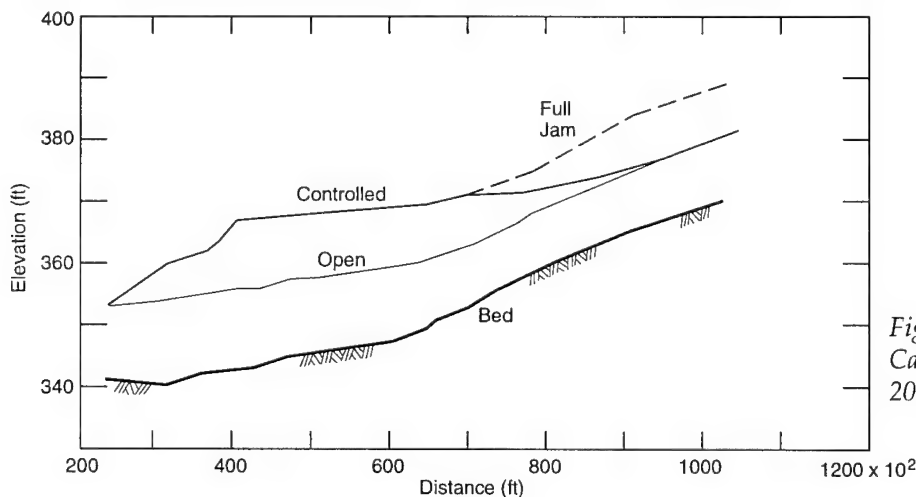
It is possible that the dam in Caribou acts as an ice-retaining structure during breakup. If so, the supply of ice to the jam at Fort Fairfield

Figure 13. Possible effect of the Caribou dam as an ICS ($Q = 20,000$ ft³/s; $h_i = 28$ in.).

would be limited to that ice present in the river between Fort Fairfield and the dam. The HEC-2 program with ice option was run for this case, for the same discharge of 20,000 ft³/s and with the additional assumption, supported by the field measurements and the calculations in Table 2, that the ice thickness averaged 28 in. The results of the computations are presented in Figure 13. With ice supply limited by the dam, we found that the jam should extend up to station 680, approximately, and that the jam backwater should merge with the open water surface profile at about station 950. Therefore, improvements to the dam to ensure that it acts as an ice-control structure would not be sufficient to alleviate ice jam flooding at Fort Fairfield. Additional mitigation means, upstream of Fort Fairfield and below the dam, would be required.

We again emphasize that in developing Figures 13 through 16 we assumed that the jams would be fully developed, a conservative assumption, and that ice volumes would correspond to a before-breakup ice cover thickness of 28 in. Depending on the actual thickness of ice formed in a given year and, especially, the extent of ice decay before breakup, the actual ice volumes, ice jam length and resulting water levels may be less.

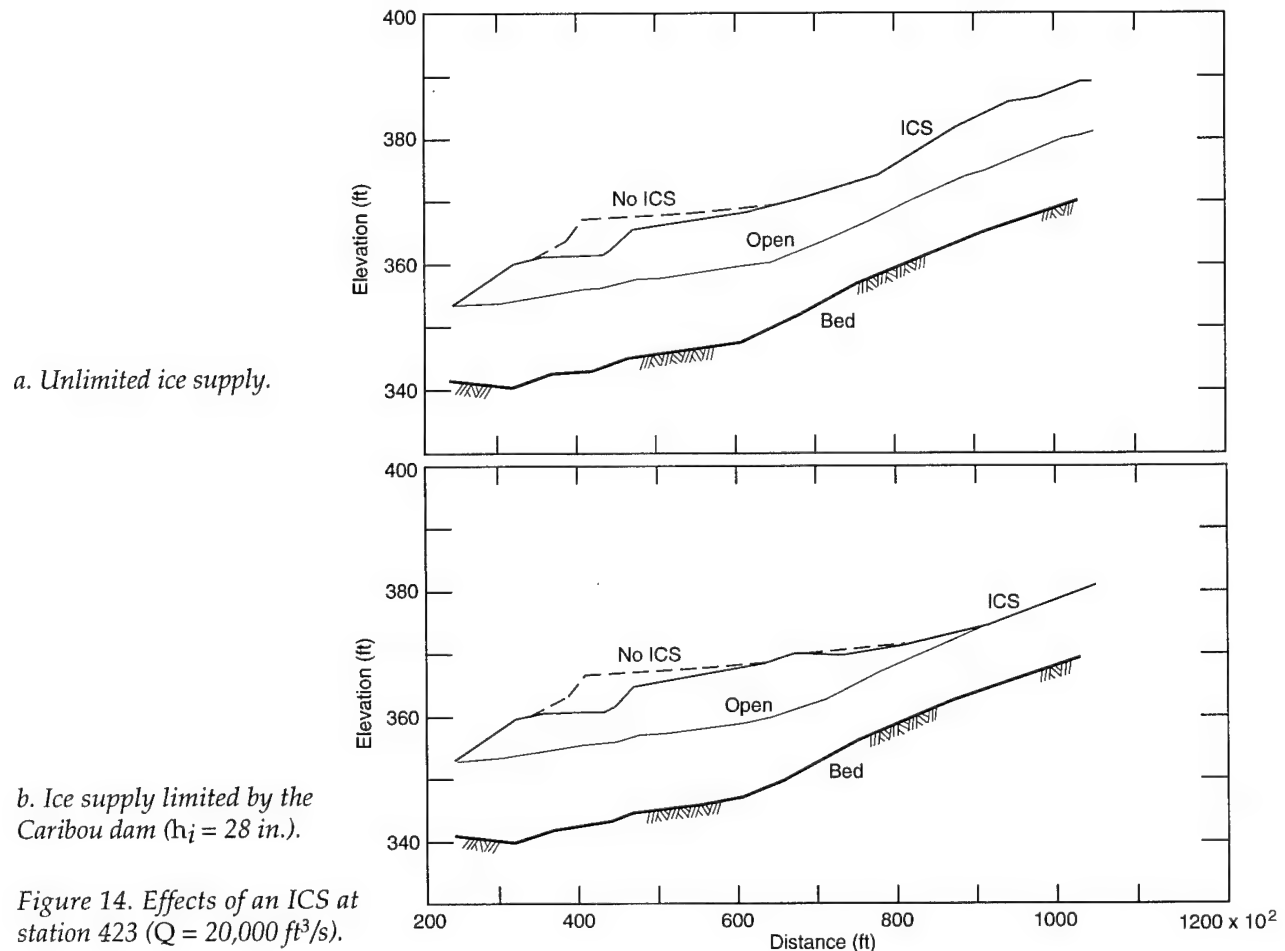
Figure 14a shows the effect of constructing an ICS at station 423+00, approximately 2000 ft upstream from the Limestone Road bridge for the case of unlimited ice supply. Figure 14b shows the effect of the same ICS when the ice supply is limited by the Caribou dam and for an ice thickness of 28 in. Both figures show that the water level is reduced by as much as 6 ft between about stations 330 and 423. Upstream of the ICS

the water level is initially reduced by about 2 ft, but at about station 630 it goes back to the level without the ICS.

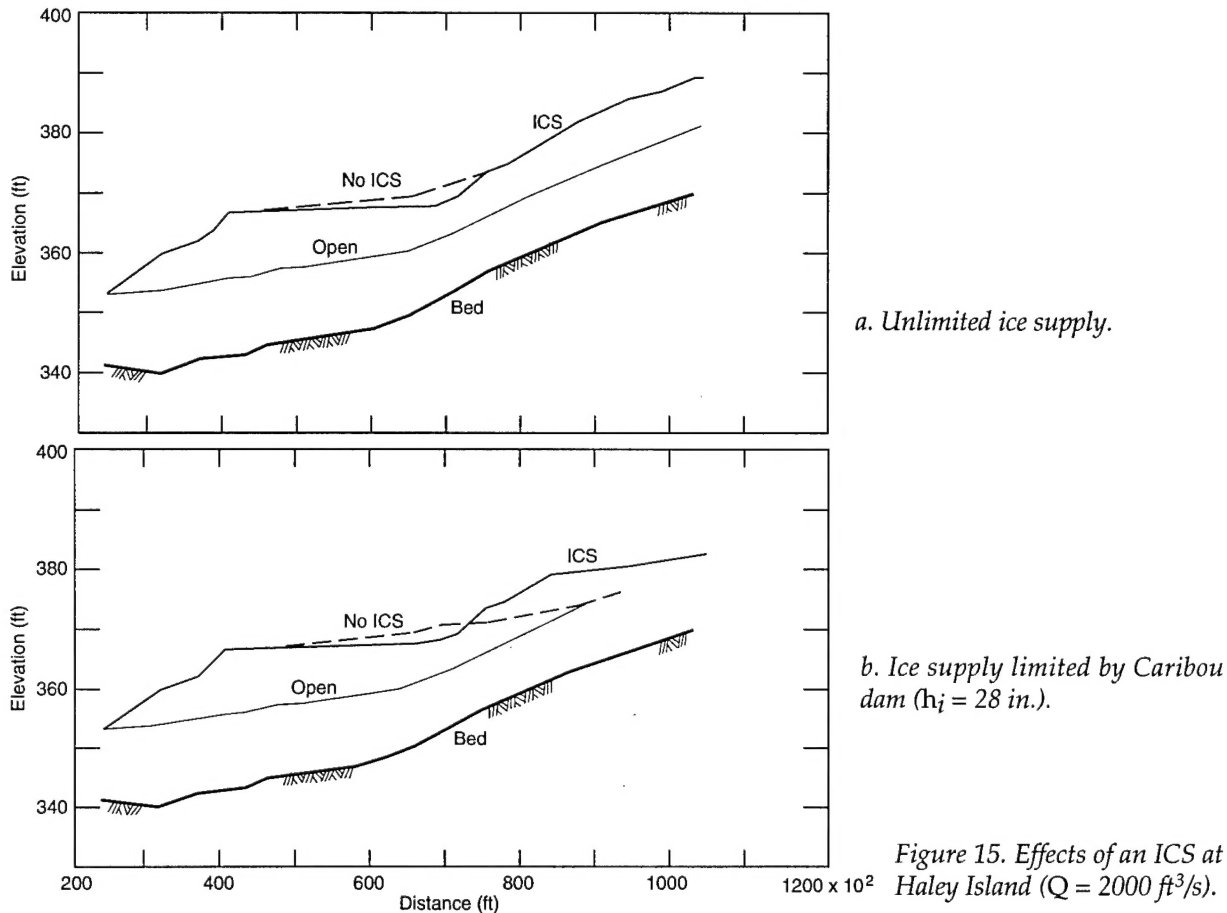
Figure 15. Effects of an ICS at Haley Island ($Q = 2000 \text{ ft}^3/\text{s}$).

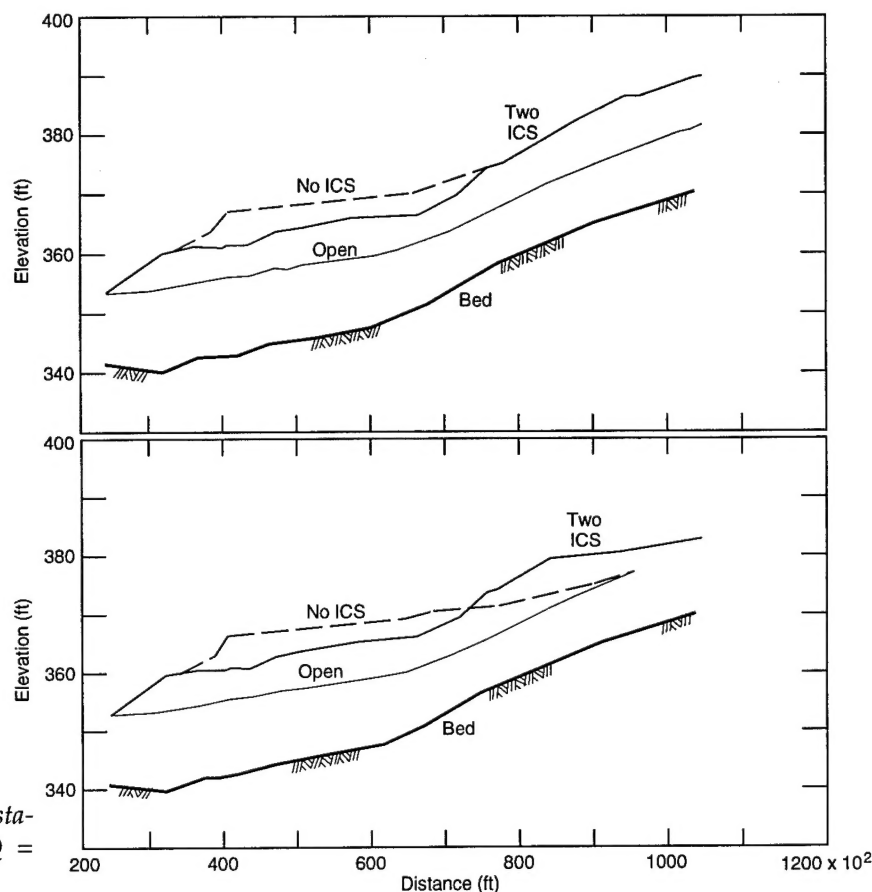
b. Ice supply limited by Caribou dam ($h_i = 28$ in.).

Figure 16. Effects of ICSs at both station 423 and Haley Island ($Q = 20,000 \text{ ft}^3/\text{s}$).
